Manhole Inspection Summary

Manhole # S15C__032MH

Location Address: **2704 FRANKLIN ST**

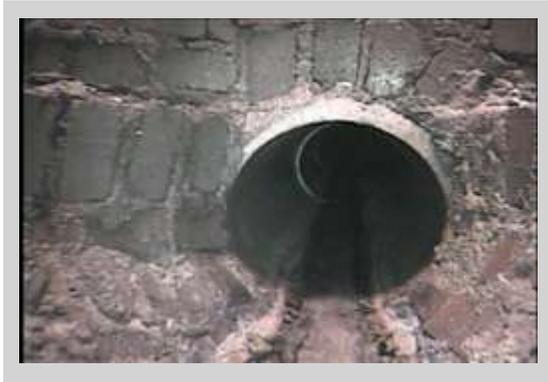
12 O'Clock Outflow

8 in. Circular Gravity Sewer
Pipe Out @ 12 O'Clock

Pipe Height: **8.4** (in.) Rod and Bar (Angled)
Pipe Material: **Clay** Pipe Lined
Invert Depth: **9.27** (ft.) Flow Characteristics: **Slow**
Deposits: None Mud Sludge Debris Grease
Silt Depth: (in.) Deposits Extent:
Infiltration: **None** Pipe Seal Cond: **Sound**

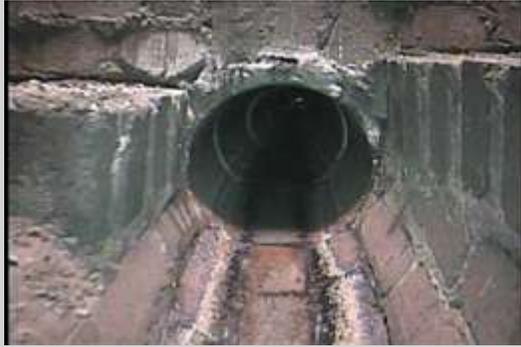
6 O'Clock Inflow

8 in. Circular Gravity Sewer

Pipe In @ 6 O'Clock

Pipe Height: **8.4** (in.) Rod and Bar (Angled)
Pipe Material: **Clay** Pipe Lined
Invert Depth: **9.05** (ft.) Flow Characteristics: **Slow**
Deposits: None Mud Sludge Debris Grease
Silt Depth: (in.) Deposits Extent:
Infiltration: **None** Pipe Seal Cond: **Sound**
